**Flood Control Project Maintenance
Levee Inspections**

Fall 2015 Levee Maintenance Deficiency Summary Report

Sacramento River Basin

Reclamation District No. 0785 Driver

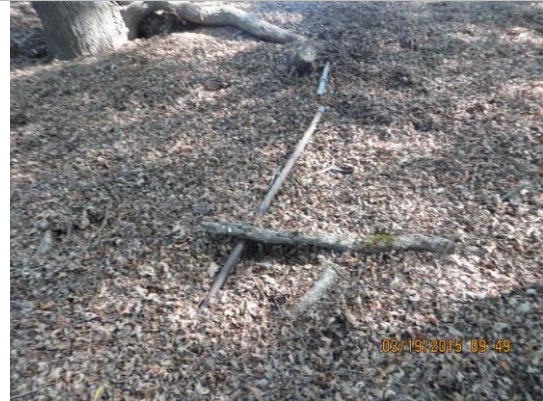
Photo 1 of 2 : UCIP_FA_2015_6384.jpg

Inspector Comments: FS_ID:43965
 DS_ID:22976
 EP_NO: N/A
 FS_HLM: 0.646
 Repair Type: Non-Urgent
 Crossing Status: Found
 UCIP Comments: Pipe appears abandoned and should be done so properly.
 FIELD_STRUCT_DESC: 1 of 2: 3/4-inch steel conduit through the levee 1-foot below the crown.
 FS Date: 03/19/2015

Pipe visible on LS slope.

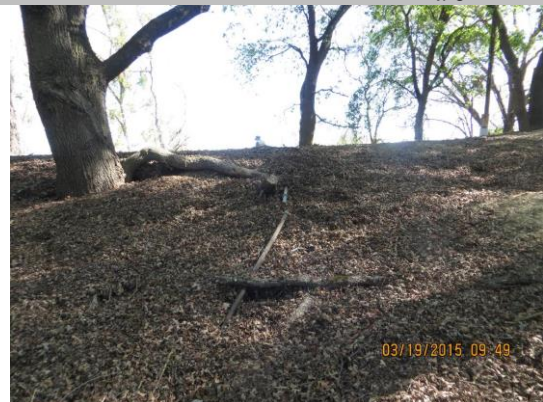
Photo 2 of 2 : UCIP_FA_2015_6385.jpg

Pipe visible on LS slope.

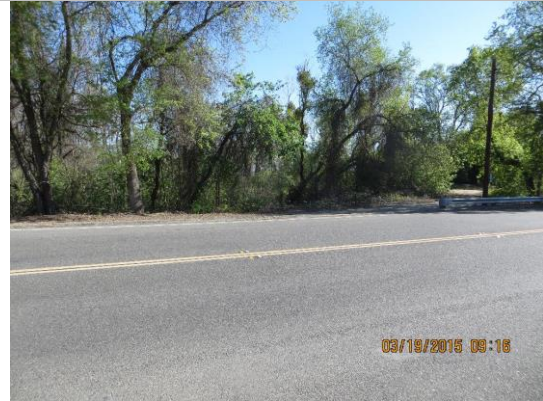
Photo 1 of 3 : UCIP_FA_2015_6095.jpg

LM Start	0.00	Rating **	U	Issue No.	358
LM End	0.00	Issue Type +	En	Location *	LS
Category	Supplemental			GPS Latitude/Longitude	
				Start	End
Item	DWR UCIP Field Study			38.660986 °	38.660986 °
				-121.613532 °	-121.613532 °
DWR ID					
Action/Comments					
Inspector Comments: FS_ID:43903					
DS_ID:22974					
EP_NO: N/A					
FS_HLM: 0					
Repair Type: Urgent					
Crossing Status: Found

WS shoulder heavily vegetated. unable to search for pipe.

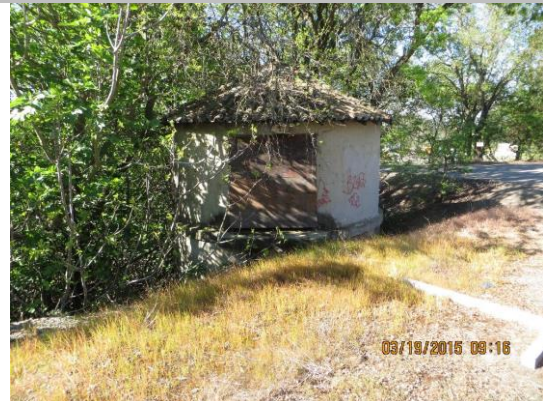
Photo 2 of 3 : UCIP_FA_2015_6096.jpg

Pumphouse on LS shoulder.

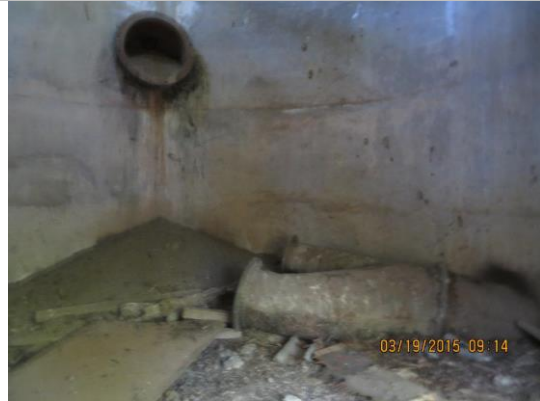
Photo 3 of 3 : UCIP_FA_2015_6097.jpg

LM Start	0.00	Rating **	U	Issue No.	358 (cont)
LM End	0.00	Issue Type +	En	Location *	LS
Category	Supplemental			GPS Latitude/Longitude	
				Start	End
Item	DWR UCIP Field Study			38.660986 °	38.660986 °
				-121.613532 °	-121.613532 °
DWR ID					
Action/Comments					
Inspector Comments: FS_ID:43903 DS_ID:22974 EP_NO: N/A FS_HLM: 0 Repair Type: Urgent Crossing Status: Found

Pipe open at base of concrete building on LS shoulder. No pump found.

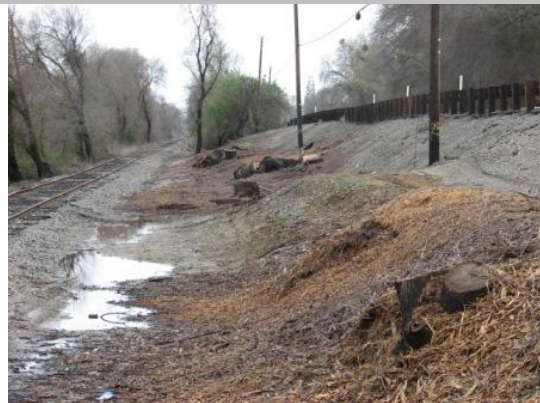
Photo 1 of 1 : FA_2015_RD0785_185_4_20150914_00003.jpg

LM Start	0.12	Rating **	N	Issue No.	4
LM End	1.34	Issue Type +	Ma	Location *	LS
Category	Earthen Levee			GPS Latitude/Longitude	
				Start	End
Item	Trim / Thin Trees			38.660160 °	38.646214 °
				-121.611619 °	-121.598596 °
DWR ID	DWR_RD0785_01_s_2012_4				
Action/Comments					
Tree stumps.

The trees were cut by PG&E'S tree contractor. The district will take care of the stumps in the future.

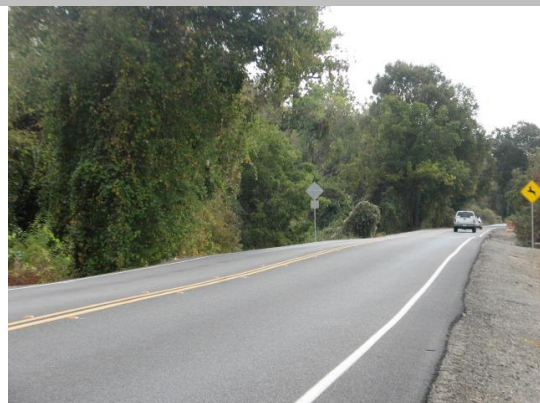
Photo 1 of 2 : FA_2015_RD0785_185_16_20150914_00011.jpg

LM Start	0.21	Rating **	M	Issue No.	16
LM End	1.35	Issue Type +	Ma	Location *	WS
Category	Earthen Levee			GPS Latitude/Longitude	
				Start	End
Item	Vegetation			38.659340 °	38.646093 °
				-121.610405 °	-121.598518 °
DWR ID	DWR_RD0785_01_f_2013_16				
Action/Comments					
Remove the wild growth other than native grasses from the levee slopes.

Brush and other vegetation partially blocks visibility or access to the levee slope. Fall 2013

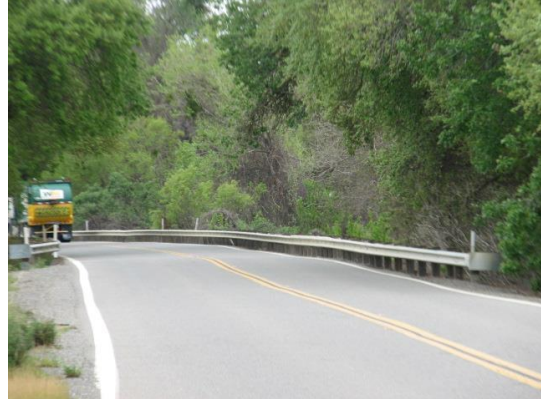
Photo 2 of 2 : FA_2015_RD0785_185_16_20150914_00012.jpg

Brush and other vegetation partially blocks visibility. Spring 2014

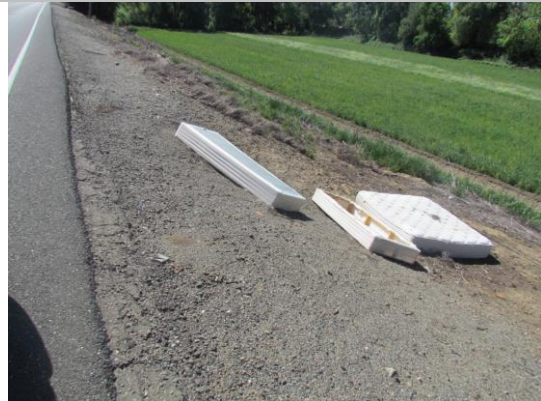
Photo 1 of 1 : FA_2015_RD0785_185_346_20150914_00019.jpg

LM Start	0.23	Rating **	M	Issue No.	346
LM End	0.23	Issue Type +	En	Location *	LS
Category	Earthen Levee			GPS Latitude/Longitude	
				Start	End
Item	Encroachments			38.659103 °	38.659103 °
				-121.610172 °	-121.610172 °
DWR ID	DWR_RD0785_01_s_2015_346				
Action/Comments					
Garbage

View of the debris on the landward side of the levee looking downward. Spring 2015.

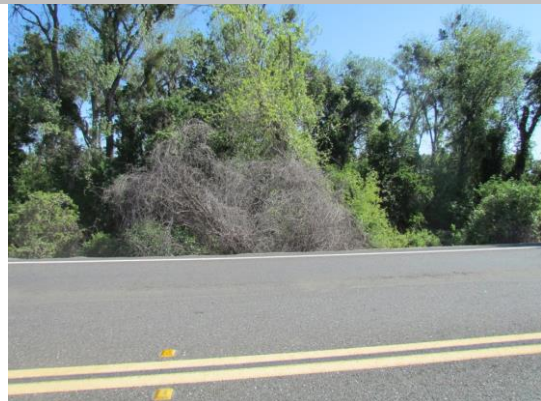
Photo 1 of 1 : FA_2015_RD0785_185_347_20150914_00020.jpg

LM Start	0.24	Rating **	M	Issue No.	347
LM End	0.24	Issue Type +	En	Location *	WS
Category	Earthen Levee			GPS Latitude/Longitude	
				Start	End
Item	Encroachments			38.658927 °	38.658927 °
				-121.610057 °	-121.610057 °
DWR ID	DWR_RD0785_01_s_2015_347				
Action/Comments					
Tree or limb

View of the tree on the waterward side of the levee taken from the landward side of the levee. Spring 2015.

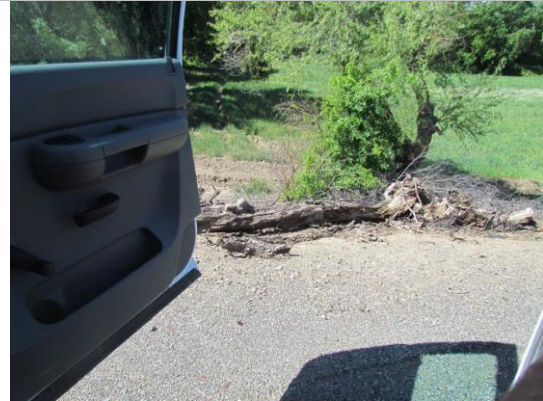
Photo 1 of 1 : FA_2015_RD0785_185_348_20150914_00021.jpg

View of the tree limb on the landward side of the levee. Spring 2015.

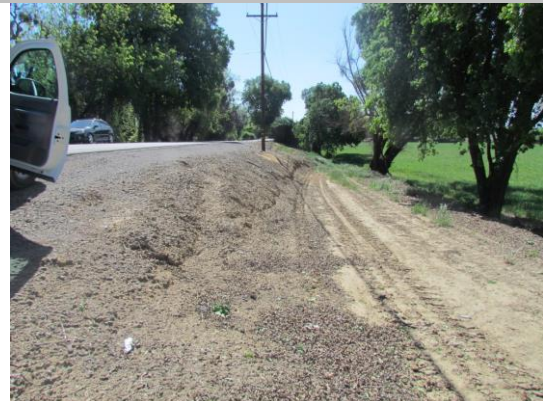
Photo 1 of 1 : FA_2015_RD0785_185_349_20150914_00022.jpg

LM Start	0.34	Rating **	M	Issue No.	349
LM End	0.34	Issue Type +	Ma	Location *	LS
Category	Earthen Levee			GPS Latitude/Longitude	
				Start	End
Item	Slope Stability			38.657798 °	38.657798 °
				-121.608898 °	-121.608898 °
DWR ID	DWR_RD0785_01_s _ 2015_349				
Action/Comments					
Repair slope instability.

View of the slope stability on the landward side of the levee looking downstream. Spring 2015.

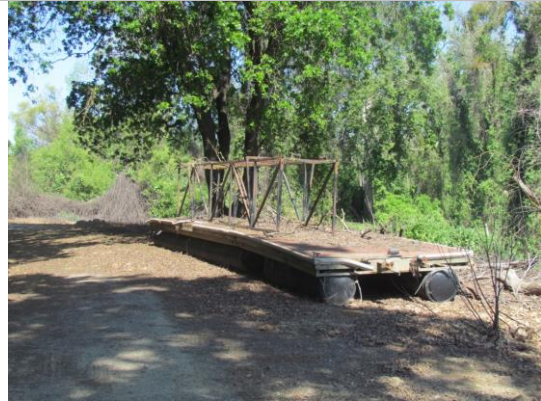
Photo 1 of 1 : FA_2015_RD0785_185_351_20150914_00024.jpg

View of a old dock on the waterward side of the levee looking upstream.
Spring 2015.

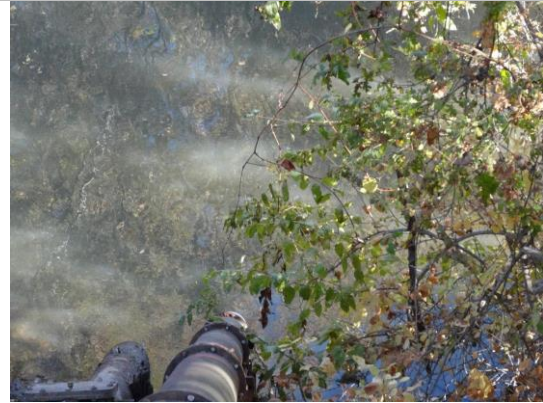
Photo 1 of 3 : UCIP_FA_2015_2574.jpg

Action/Comments					
Inspector Comments: FS_ID:43963 DS_ID:22982 EP_NO: N/A FS_HLM: 0.647 Repair Type: Non-Urgent Crossing Status: Found UCIP Comments: Part of abandoned pipe also found on waterside that should be removed.No access to landside across the highway. FIELD_STRUCT_DESC: 2 of 2: 12-inch steel irrigation pipe through the levee, 11.0-feet below the crown, slant pump on the waterside slope. Pipe crosses under highway fill and discharge into irrigation ditch. FS Date: 11/21/2013

WS view: two steel pipes on levee slope. Abandoned pipe on left.

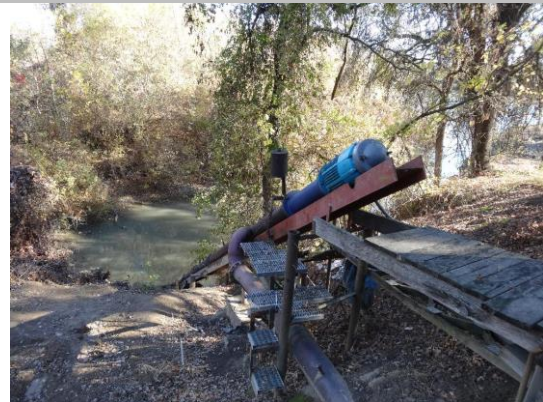
Photo 2 of 3 : UCIP_FA_2015_2575.jpg

WS view: slant pump and walkway on levee slope.

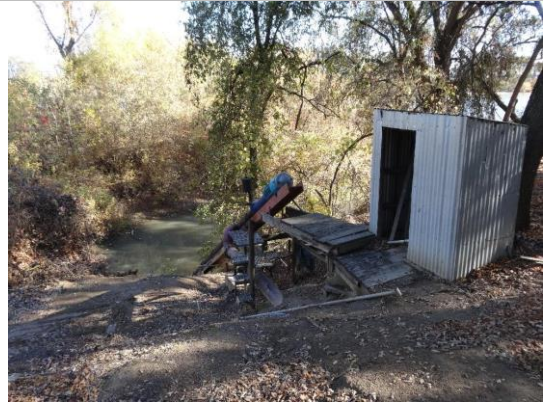
Photo 3 of 3 : UCIP_FA_2015_2576.jpg

WS view: slant pump, walkway, and electric control box in shed on levee slope.

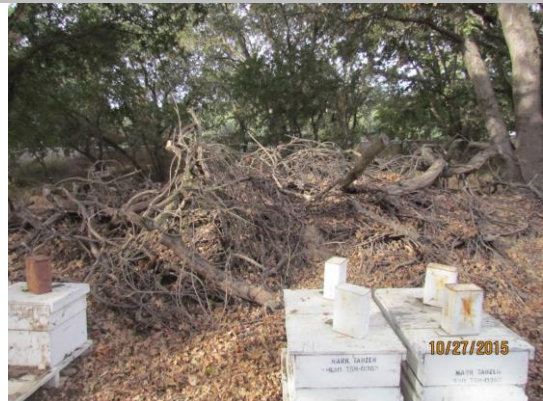
Photo 1 of 1 : FA_2015_RD0785_185_14_20151102_00027.jpg

LM Start	0.67	Rating **	M	Issue No.	14
LM End	0.67	Issue Type +	En	Location *	LS
Category	Earthen Levee			GPS Latitude/Longitude	
				Start	End
Item	Encroachments			38.654207 °	38.654207 °
				-121.605141 °	-121.605141 °
DWR ID	DWR_RD0785_01_f_2015_14				
Action/Comments					
Prunings

View of the prunings on the landward side of the levee. Fall 2015.

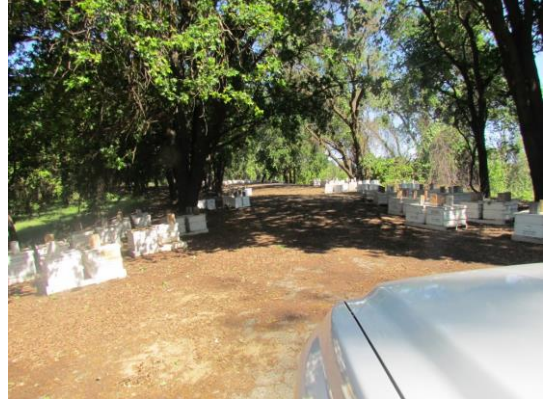
Photo 1 of 2 : FA_2015_RD0785_185_350_20150914_00023.jpg

View of the beehives on the crown of the levee looking upstream. Spring 2015.

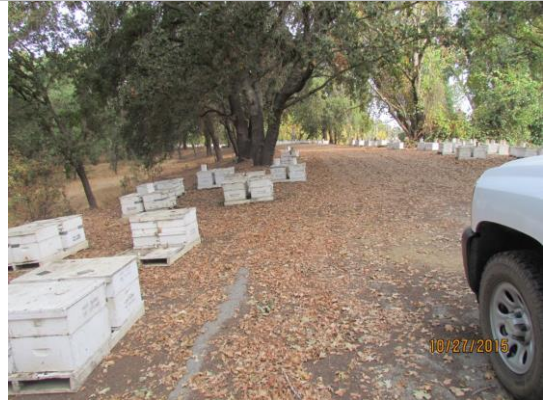
Photo 2 of 2 : FA_2015_RD0785_185_350_20151102_00026.jpg

LM Start	0.72	Rating **	A/W	Issue No.	350 (cont)
LM End	0.72	Issue Type +	En	Location *	CR

View of the beehives on the crown of the levee looking upstream. Fall 2015.

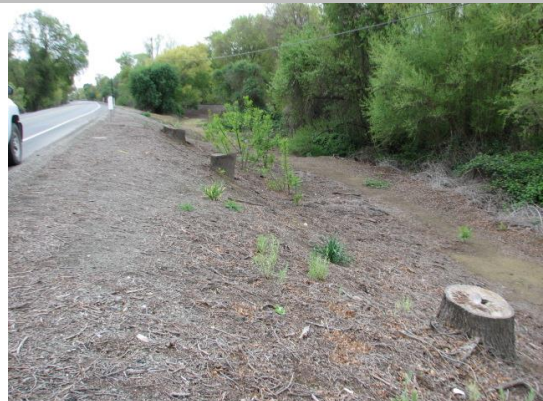
Photo 1 of 1 : FA_2015_RD0785_185_181_20150914_00018.jpg

LM Start	0.76	Rating **	N	Issue No.	181
LM End	0.76	Issue Type +	Ma	Location *	LS
Category	Earthen Levee			GPS Latitude/Longitude	
				Start	End
Item	Trim / Thin Trees			38.653003 °	38.653003 °
				-121.605061 °	-121.605061 °
DWR ID	DWR_RD0785_01_s _ 2014_181				
Action/Comments					
Tree stumps.

Tree stumps along the landside shoulder of the levee. Spring 2014

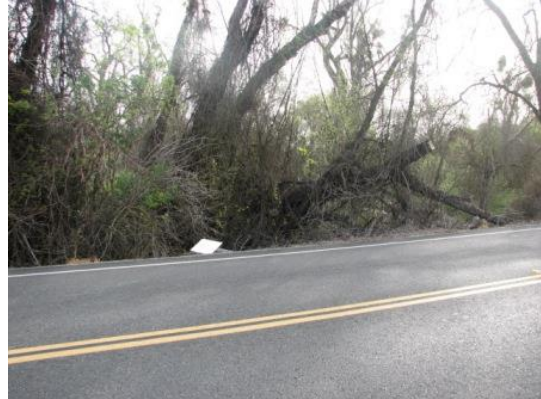
Photo 1 of 1 : FA_2015_RD0785_185_47_20150914_00014.jpg

The fallen tree and brush on the waterside of the roadway needs to be removed. Photo taken spring 2012.

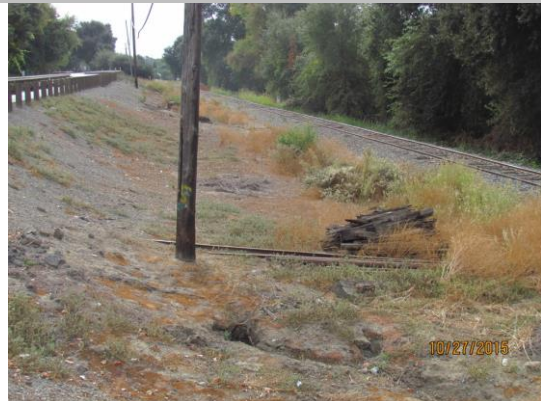
Photo 1 of 1 : FA_2015_RD0785_185_12_20151102_00028.jpg

LM Start	1.06	Rating **	M	Issue No.	12
LM End	1.06	Issue Type +	En	Location *	LS
Category	Earthen Levee			GPS Latitude/Longitude	
				Start	End
Item	Encroachments			38.649355 °	38.649355 °
				-121.601760 °	-121.601760 °
DWR ID	DWR_RD0785_01_s_2013_12				
Action/Comments					
Debris

View of the railroad ties and rails at the toe of the landward side of the levee looking downstream. Fall 2015.

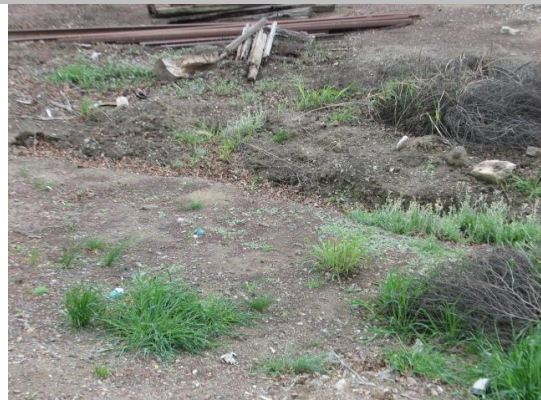
Photo 1 of 2 : FA_2015_RD0785_185_48_20150914_00017.jpg

LM Start	1.07	Rating **	M	Issue No.	48
LM End	1.07	Issue Type +	Ma	Location *	LS
Category	Earthen Levee			GPS Latitude/Longitude	
				Start	End
Item	Erosion / Bank Caving			38.649292 °	38.649292 °
				-121.601647 °	-121.601647 °
DWR ID	DWR_RD0785_01_s_2012_48				
Action/Comments					
Schedule repair of erosion site prior to the next inspection.

Drain pipe is causing erosion on the landside of the levee between the slope and railroad tracks. Spring 2014

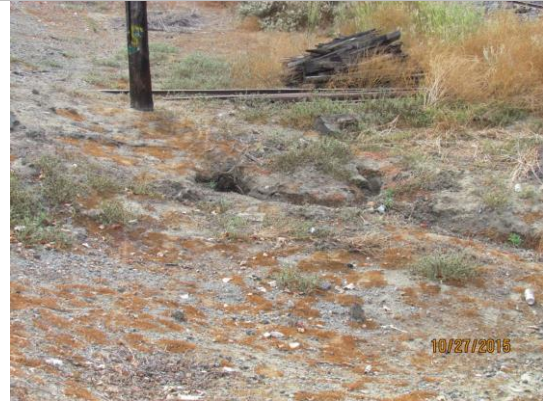
Photo 2 of 2 : FA_2015_RD0785_185_48_20151102_00029.jpg

LM Start	1.07	Rating **	M	Issue No.	48 (cont)
LM End	1.07	Issue Type +	Ma	Location *	LS
Category	Earthen Levee			GPS Latitude/Longitude	
				Start	End
Item	Erosion / Bank Caving			38.649292 °	38.649292 °
				-121.601647 °	-121.601647 °
DWR ID	DWR_RD0785_01_s _ 2012_48				
Action/Comments					
Schedule repair of erosion site prior to the next inspection.

View of the erosion at the toe of the levee on the landward side of the levee looking downstream. Fall 2015.

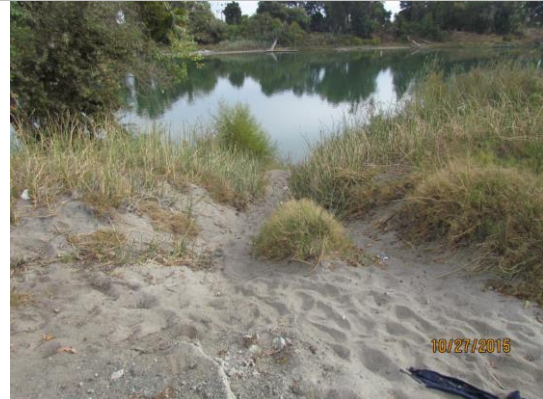
Photo 1 of 1 : FA_2015_RD0785_185_13_20151102_00030.jpg

LM Start	1.31	Rating **	M	Issue No.	13
LM End	1.31	Issue Type +	Ma	Location *	WS
Category	Earthen Levee			GPS Latitude/Longitude	
				Start	End
Item	Slope Stability			38.646671 °	38.646671 °
				-121.598915 °	-121.598915 °
DWR ID	DWR_RD0785_01_s_2013_13				
Action/Comments					
Repair the levee slope damaged by vehicle traffic and prevent access where possible.

View of the slope stability on the waterward side of the levee. Fall 2015.

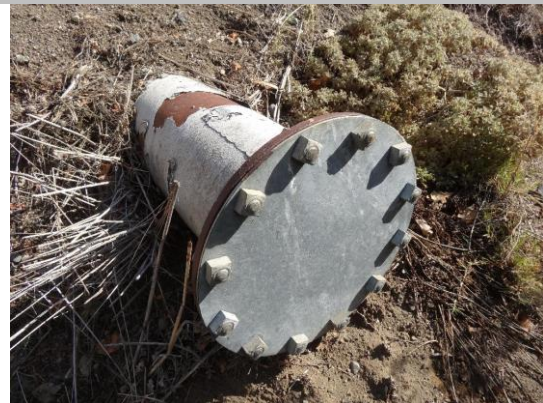
Photo 1 of 2 : UCIP_FA_2015_2112.jpg

LM Start	1.31	Rating **	M	Issue No.	360
LM End	1.31	Issue Type +	En	Location *	WS
Category	Supplemental			GPS Latitude/Longitude	
				Start	End
Item	DWR UCIP Field Study			38.646547 °	38.646547 °
				-121.598924 °	-121.598924 °
DWR ID					
Action/Comments					
Inspector Comments: FS_ID:41984 DS_ID:22978 EP_NO: N/A FS_HLM: 1.331 Repair Type: Non-Urgent Crossing Status: Found UCIP Comments: Dense vegetation on waterside. No pipe found/visible on waterside. FIELD_STRUCT_DESC: 12-inch steel pipe through levee, 6.0 feet below crown. Plate bolted on both ends. FS Date: 11/21/2013

LS view: plate bolted pipe on levee slope.

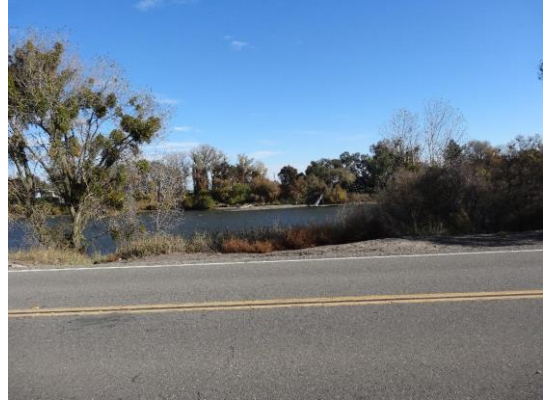
Photo 2 of 2 : UCIP_FA_2015_2113.jpg

LM Start	1.31	Rating **	M	Issue No.	360 (cont)	
LM End	1.31	Issue Type +	En	Location *	WS	
Category	Supplemental			GPS Latitude/Longitude		
				Start	End	
Item	DWR UCIP Field Study			38.646547 °	38.646547 °	
				-121.598924 °	-121.598924 °	
DWR ID						
Action/Comments						
Inspector Comments: FS_ID:41984						
DS_ID:22978						
EP_NO: N/A						
FS_HLM: 1.331						
Repair Type: Non-Urgent						
Crossing Status: Found						
UCIP Comments: Dense vegetation on waterside. No pipe found/visible on waterside.						
FIELD_STRUCT_DESC: 12-inch steel pipe through levee, 6.0 feet below crown. Plate bolted on both ends.						
FS Date: 11/21/2013

WS view: crown and waterside. No pipe found due to dense vegetation.

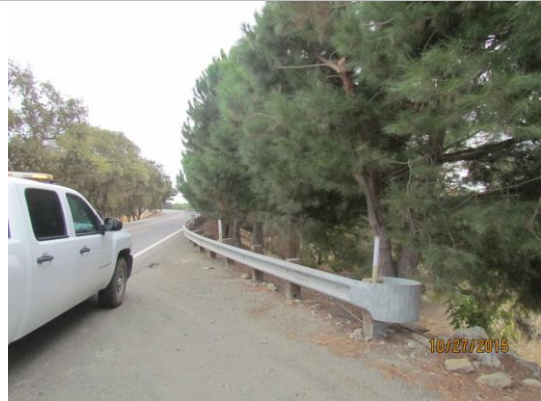
Photo 1 of 1 : FA_2015_RD0785_185_8_20151102_00031.jpg

View of the pines on the shoulder of the landward side of the levee looking downstream. Fall 2015.

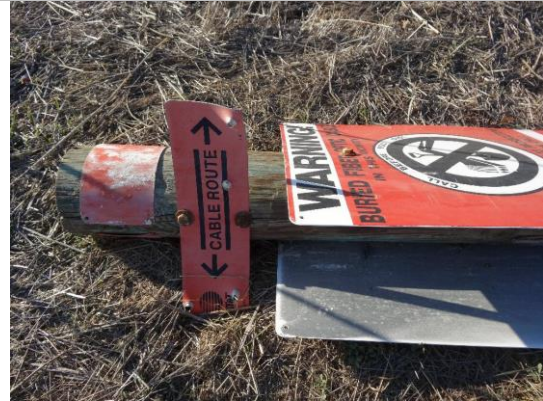
Photo 1 of 2 : UCIP_FA_2015_2104.jpg

Inspector Comments: FS_ID:24750
 DS_ID:22985
 EP_NO: 16982
 FS_HLM: 0
 Repair Type: Non-Urgent
 Crossing Status: Indicator Found
 UCIP Comments: Only a damaged indicator post found on landside across the road. Damaged indicator needs to be fixed.
 FIELD_STRUCT_DESC: Three 2-inch-diameter and three 1.5-inch diameter HDPE conduits containing fiber optic cables across and under the east levee (County Road 124), 67 feet below the crown. HDPE pipes were pulled through an 8-inch bore hole and backfilled with bentonite. (App. No. 16982 - Pacific Fiber Link)
 FS Date: 12/02/2013

LS view: closer view of damaged indicator post.

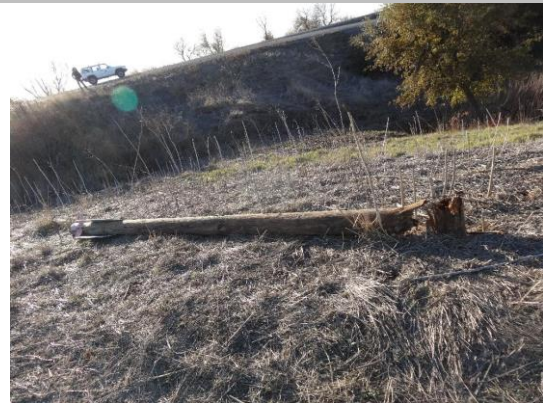
Photo 2 of 2 : UCIP_FA_2015_2105.jpg

LS view: damaged indicator post across the levee road.

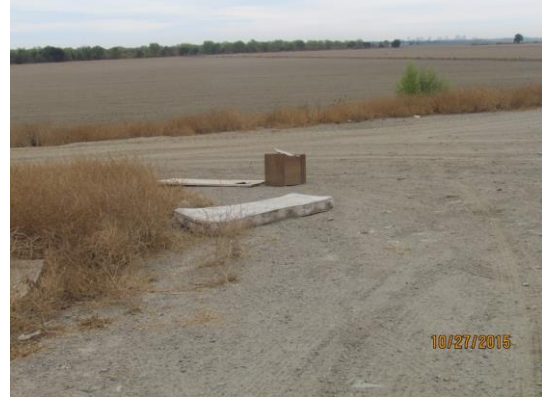
Photo 1 of 1 : FA_2015_RD0785_186_3_20151102_00019.jpg

View of the debris on the landward side of the levee. Fall 2015.

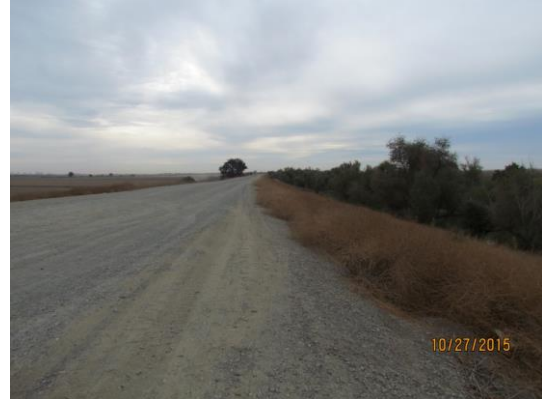
Photo 1 of 1 : FA_2015_RD0785_186_2_20151102_00017.jpg

View of the vegetation on the waterward side of the levee looking downstream. Fall 2015.

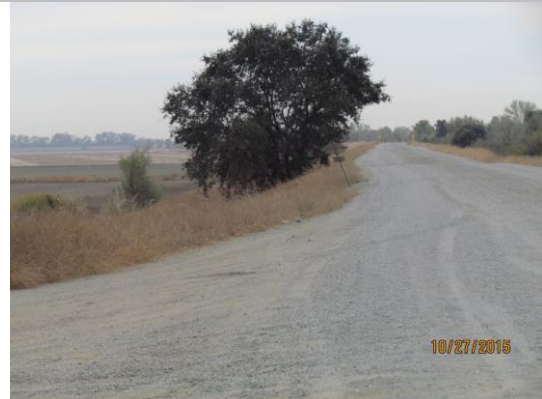
Photo 1 of 1 : FA_2015_RD0785_186_4_20151102_00018.jpg

View of the vegetation on the landward side of the levee looking downstream. Fall 2015.

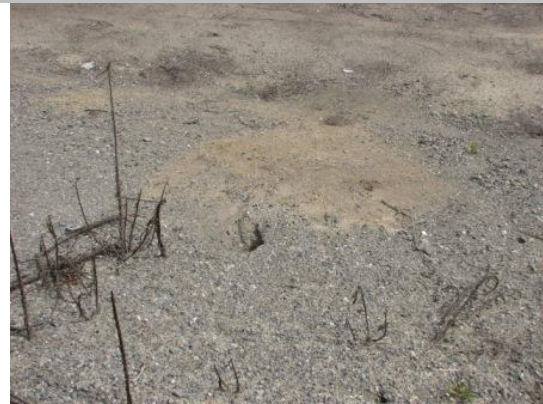
Photo 1 of 1 : FA_2015_RD0785_186_25_20150914_00001.jpg

Rodent holes on the landside levee slope, photo taken spring 2012.

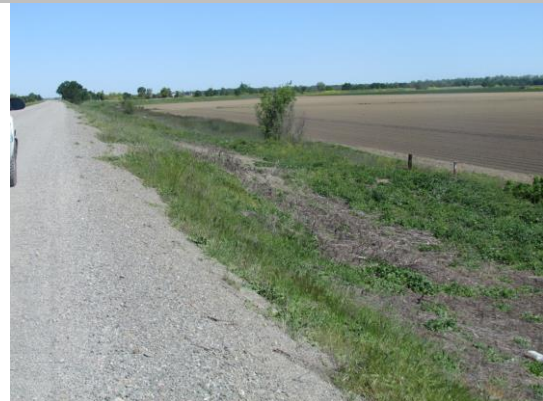
Photo 1 of 1 : FA_2015_RD0785_186_280_20150914_00015.jpg

LM Start	0.38	Rating **	M	Issue No.	280
LM End	0.38	Issue Type +	Ma	Location *	LS
Category	Earthen Levee			GPS Latitude/Longitude	
				Start	End
Item	Slope Stability			38.636265 °	38.636265 °
				-121.617422 °	-121.617422 °
DWR ID	DWR_RD0785_02_s_2015_280				
Action/Comments					
Repair slope instability.

View of the slope stability on the landward side of the levee looking upstream. Spring 2015.

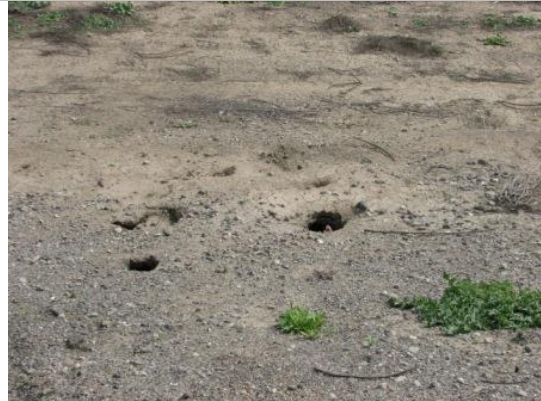
Photo 1 of 1 : FA_2015_RD0785_186_27_20150914_00002.jpg

Rodent holes on the landside levee slope, photo taken spring 2012.

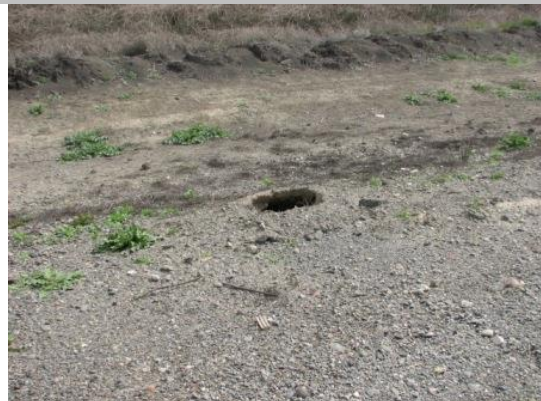
Photo 1 of 2 : FA_2015_RD0785_186_28_20150914_00003.jpg

Many rodent holes with in 25' of each other, photo taken spring 2012.

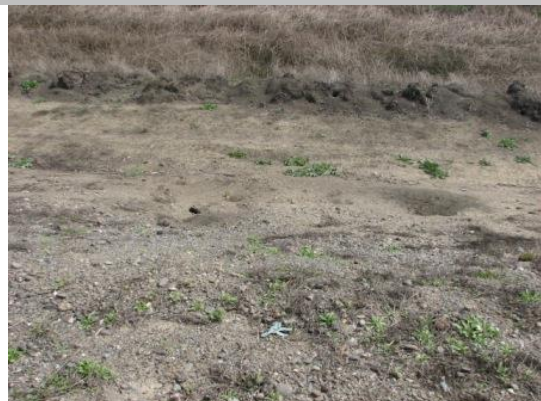
Photo 2 of 2 : FA_2015_RD0785_186_28_20150914_00004.jpg

LM Start	0.48	Rating **	A/W	Issue No.	28 (cont)
LM End	0.48	Issue Type +	Ma	Location *	LS

Rodent holes on the landside levee slope, photo taken spring 2012.

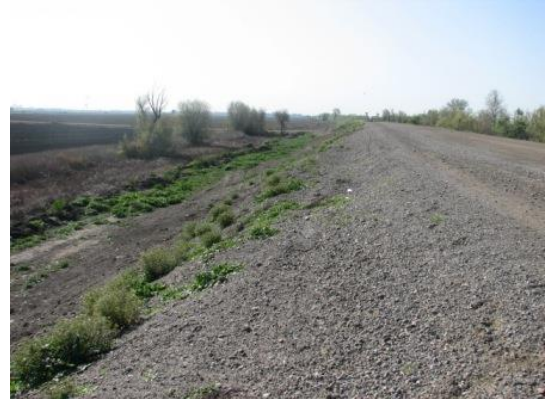
Photo 1 of 2 : FA_2015_RD0785_186_29_20150914_00005.jpg

LM Start	0.54	Rating **	M	Issue No.	29
LM End	0.54	Issue Type +	Ma	Location *	LS
Category	Earthen Levee			GPS Latitude/Longitude	
				Start	End
Item	Slope Stability			38.634180 °	38.634180 °
				-121.616142 °	-121.616142 °
DWR ID	DWR_RD0785_02_s _ 2012_29				
Action/Comments					
Repair slope instability.

Slope instability at shoulder of landside levee buldge at toe.

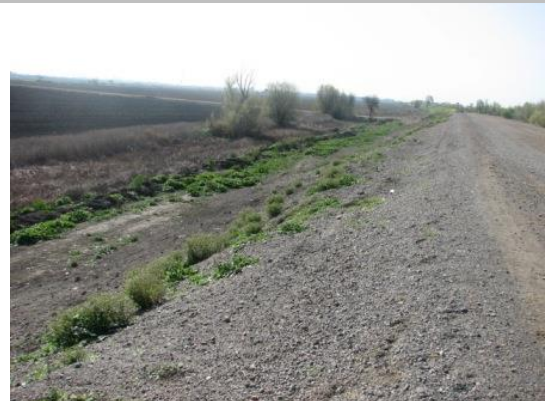
Photo 2 of 2 : FA_2015_RD0785_186_29_20150914_00006.jpg

Buldge at the landside toe of the levee, photos taken spring 2012.

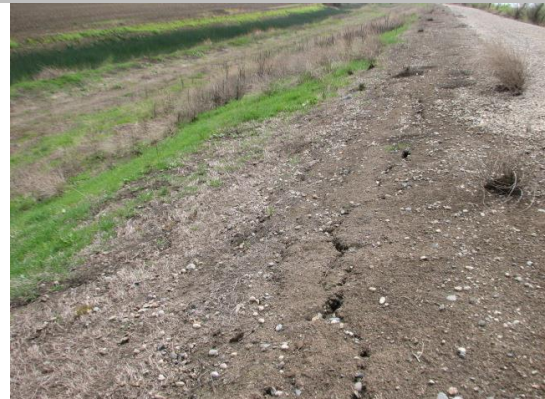
Photo 1 of 1 : FA_2015_RD0785_186_143_20150914_00013.jpg

LM Start	0.88	Rating **	M	Issue No.	143
LM End	0.88	Issue Type +	Ma	Location *	LS
Category	Earthen Levee			GPS Latitude/Longitude	
				Start	End
Item	Slope Stability			38.629693 °	38.629693 °
				-121.613436 °	-121.613436 °
DWR ID	DWR_RD0785_02_s _ 2014_143				
Action/Comments					
Repair slope instability.

Cracking along the shoulder causing slope instability. Spring 2014

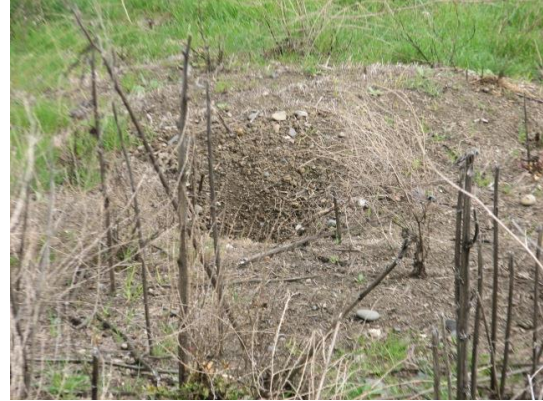
Photo 1 of 1 : FA_2015_RD0785_186_42_20150914_00011.jpg

Large rodent hole close to the toe of the levee. Spring 2014

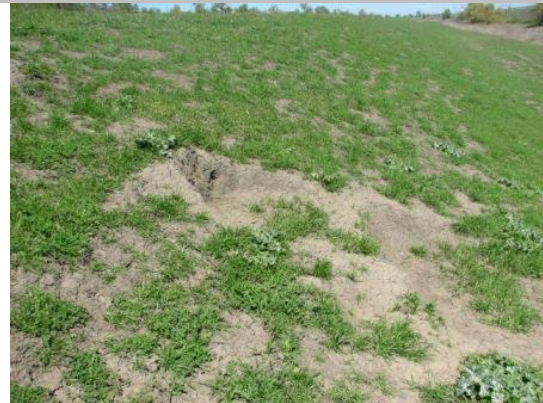
Photo 1 of 4 : FA_2015_RD0785_186_30_20150914_00007.jpg

There is slope instability with three step like spots. The cuts are 1' to 1.5' deep. Photo taken spring 2012.

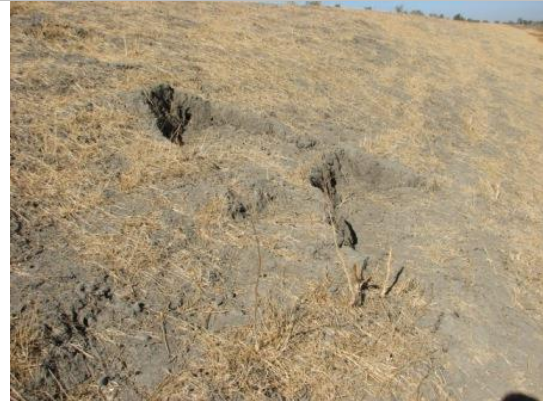
Photo 2 of 4 : FA_2015_RD0785_186_30_20150914_00008.jpg

Slope instability. Photo fall 2012.

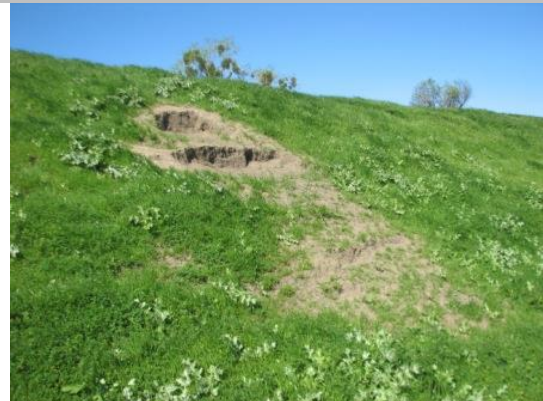
Photo 3 of 4 : FA_2015_RD0785_186_30_20150914_00009.jpg

Slope instability is still there. Spring 2013

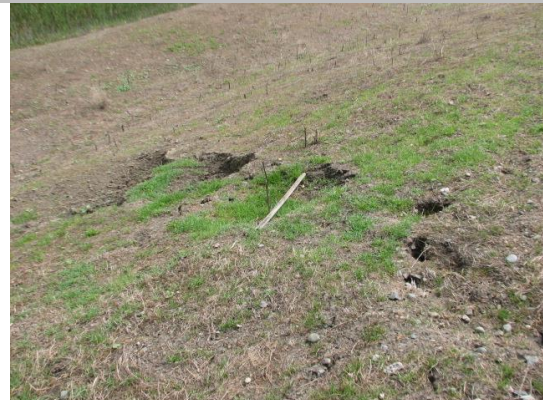
Photo 4 of 4 : FA_2015_RD0785_186_30_20150914_00010.jpg

Current view of the slope instability. Spring 2014

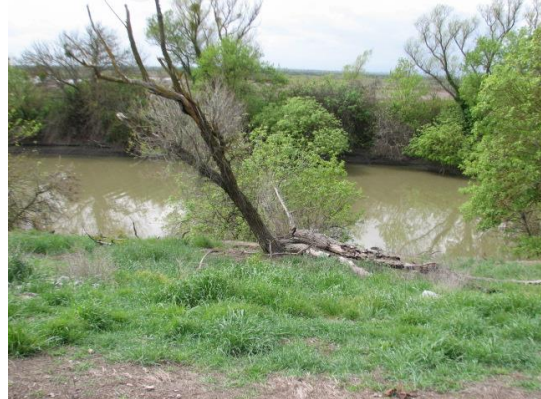
Photo 1 of 2 : FA_2015_RD0785_186_56_20150914_00012.jpg

Discarded branches lay at the toe of the levee. The trees is about to fall over and may cause damage to the levee. Spring 2014

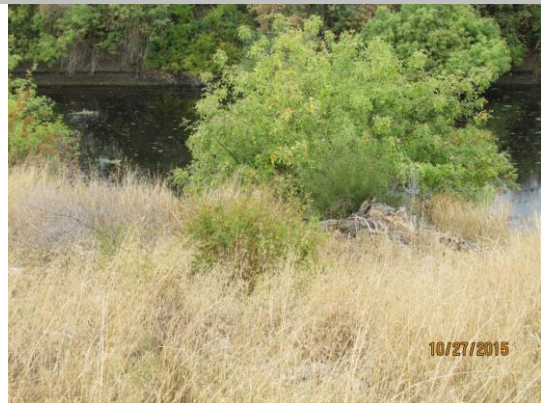
Photo 2 of 2 : FA_2015_RD0785_186_56_20151102_00020.jpg

The tree has fallen and is hidden behind the vegetation. Fall 2015.
